Manhole Inspection Summary

Manhole # S69S__022MH

Location Address: **6423 Danville Ave.**

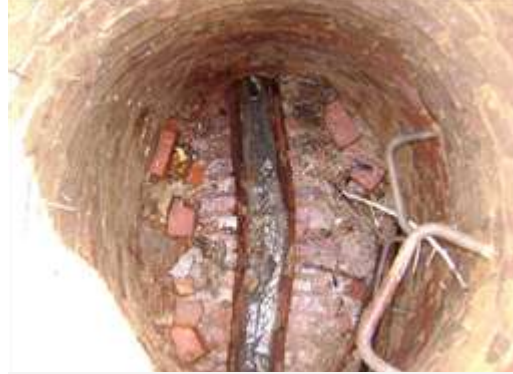
Top View

Condition: ☐ Sound ☐ Cracked ☐ Root Intrusion ☒ **Loose Brick** ☒ **Deteriorated**

Infiltration: ☐ None ☒ **Joint** ☐ Cracks ☒ **Mortar** ☐ Roots ☐ Wall
